Embrittlement of a Platinum-Iridium Screen

10 January 1999

G. L. STECKEL and N. MARQUEZ
Mechanics and Materials Technology Center
Technology Operations

**THE AEROSPACE
CORPORATION**
El Segundo, California

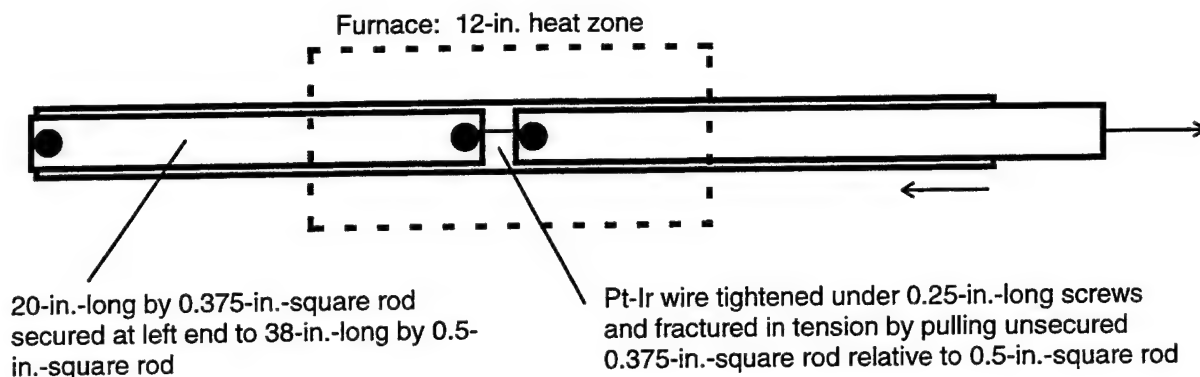
In view of the surprising fracture resistance of the Mesh A wires during handling, it was hypothesized that the wires might be ductile at room temperature, but brittle at the firing temperature. Therefore, individual wires 0.50–0.75-in. long were extracted from Mesh A and Mesh B for the purpose of determining the tensile fracture mode at temperatures from 23 to 950°C (73 to 1740°F). These wires were extracted from the quadrant edge labeled A5, B5, C5 in Figure 6. The simple apparatus shown in Figure 7 was constructed to manually fracture the short wires in tension in a tube furnace. The elevated-temperature tensile fractures were created in an air atmosphere. Extracted wires were also used to perform various contamination experiments, which will be discussed below.

Figure 7. Stainless-steel rod assembly for fracturing Pt-Ir wires in tension at high temperatures.

The apparatus shown in Figure 7 was used to manually tensile fracture the 0.5–0.75-in.-long wires extracted from Mesh A and Mesh B. Wires extracted from Mesh A were pulled to failure at 23, 300, and 900°C (73, 570, and 1650°F). Wires extracted from Mesh B were pulled to failure at 23, 850, and 950°C (73, 1560, and 1740°F). The tests were performed at 23°C because handling of Quadrant No. 2 indicated that Mesh A wires could be deformed much further at room temperature without fracturing than was anticipated. 300°C (570°F) was selected as a temperature somewhat higher than the maximum temperature, 190°C (375°F) that the REM was exposed to after potential exposure to diffusion pump oil. Tests were performed at 850–950°C (1560–1740°F) because these temperatures approach the maximum temperature, 980°C (1800°F) that the up stream screens were estimated to have seen during motor firing.

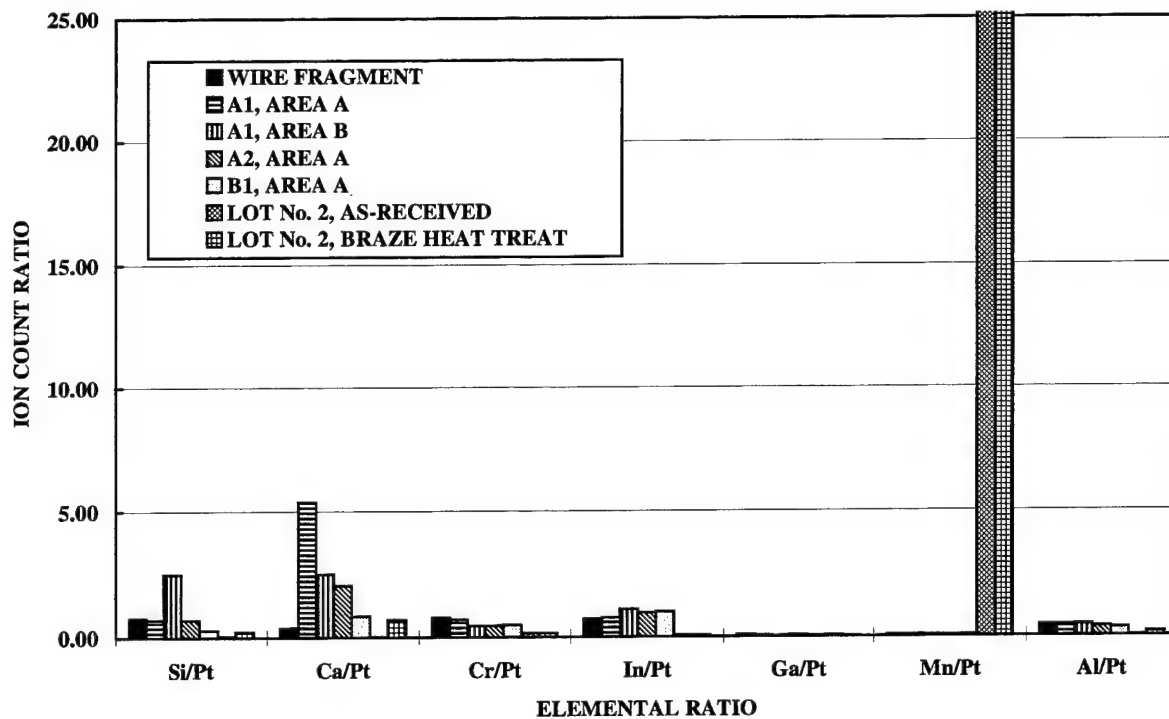
The results of the spectral analyses of the cross sections are shown in Table 2. The numbers of secondary-ion counts are given in the top of the table, and the ion count ratios relative to Pt are given in the bottom of the table and in the bar chart in Figure 13. The atomic mass for the peak used for the ion

counts is indicated in parentheses for each element or compound. Spectral data are presented for two separate areas on Sample Nos. A1 and A2, and for one area on all other samples. Similar elemental spectra were obtained for the wire fragment, the two areas on Sample Nos. A1 and A2, and the one area on Sample No. B1. The primary impurities were Cr, Rh, Al, In, Si, and Ca. Rh was not included in Table 2 or Figure 13 since the presence of Rh is expected and is of no concern. Indium was the most surprising impurity and appeared to be present in significant levels, although not at concentrations sufficient to be detected by SEM/EDX. Cr, Rh, Si, and Ca were all detected in the bulk chemical analysis (Table 1), while Al was not detected, and In was not checked for in the bulk analysis. Elemental mapping indicated that the Cr, Rh, Al, and In were distributed uniformly throughout the cross section. The Ca and Si were associated with one another and appeared to be present as distinct particles, as shown by the elemental maps in Figure 14 for Sample No. A2, Area B.

Figure 13. Primary impurities detected in SIMS analysis of cross sections of Pt-Ir wire fragment and Mesh A, Mesh B, and Lot No. 2 screens.

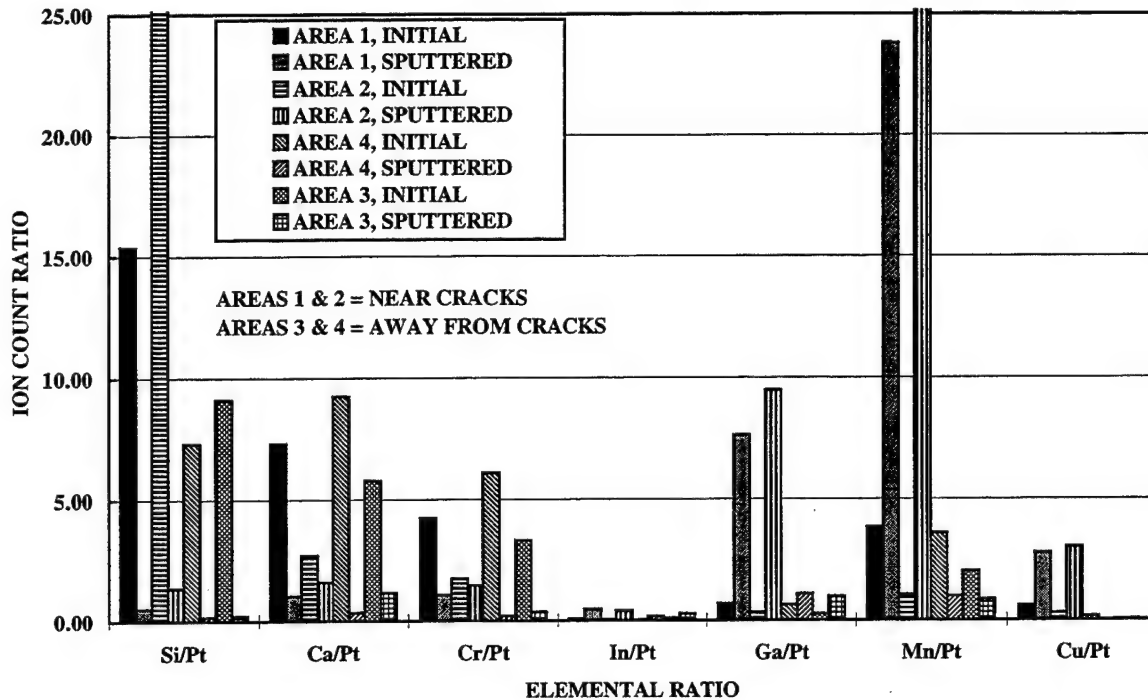
Once it was determined that the SIMS analysis of cross sections did not identify any cause for the wire embrittlement, samples from each of the three screens were prepared for surface analyses. The results for Sample No. A3 will be presented first, followed by results for Sample Nos. B3 and C3. The results of the spectral analyses for Sample No. A3 are presented in Table 3 and by the bar chart in Figure 16. Four areas were analyzed, including two high points that had cracks completely across

Figure 16. Primary impurities detected in SIMS analysis of surfaces of Pt-Ir screen sample No. A3.

the wire strands, one high point that did not have any cracks, and one saddle point. The areas analyzed on the cracked wires were adjacent to the cracks. Initial surface spectra were obtained at each area followed by sputtering for up to 90 min. Additional spectra were taken after 30, 60, and 90 min of sputtering. Results for the initial and final spectra will be discussed. The 30 and 60 min spectra were either intermediate between the initial and final spectra or were very similar to the final spectra.

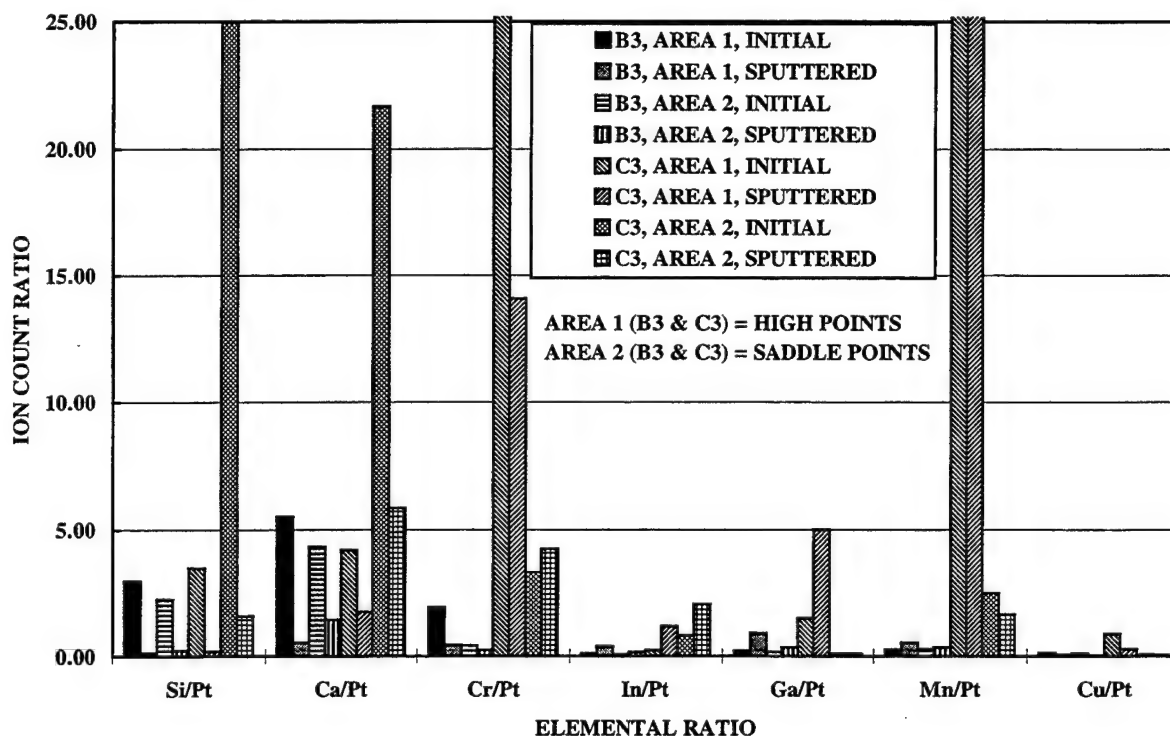
The results for Sample Nos. B3 and C3 are presented in Table 4 and Figure 17. One high point and one saddle point were analyzed for both B3 and C3. Spectra were taken for the initial surfaces and

Figure 17. Primary impurities detected in SIMS analysis of surfaces of Pt-Ir screen sample Nos. B3 & C3.

after up to 90 min of sputtering. For Sample No. B3, similar results were obtained at the high point and saddle point. Aside from Al from the catalyst particles, Si and Ca were the primary impurities on the surface. Both decreased significantly during sputtering. There were only traces of In, Ga, Mn, or Cu before or after sputtering.

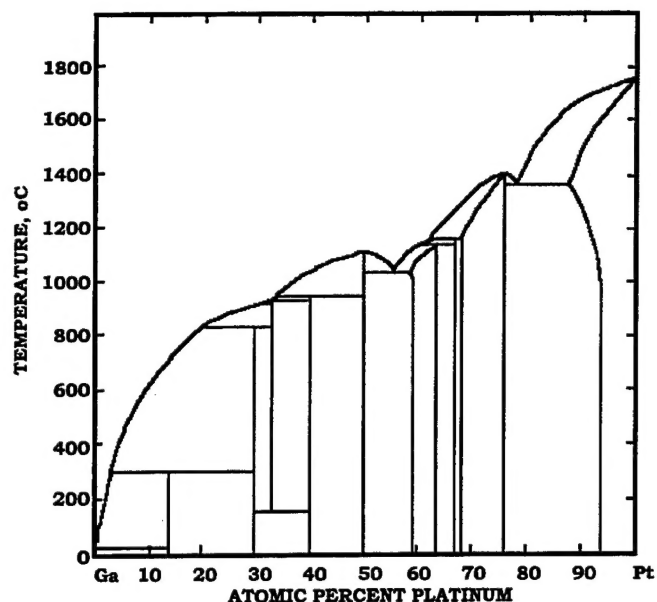
Liquid-metal embrittlement (LME) is the catastrophic brittle failure of a normally ductile metal when coated with a thin film of a liquid metal and subsequently stressed in tension.⁸ The fracture is usually brittle intergranular, with little indication of crack branching or striations to indicate slow crack growth. In general, LME fracture surfaces are completely covered by the liquid metal. However, in some cases very small quantities of liquid are required, making detection of the liquid metal on the fracture surface very difficult. LME is usually caused by low-melting-point metals. Liquid metals that have been reported to cause LME include lead, bismuth, cadmium, mercury, lithium, zinc, gallium, indium, and many others. The fact that Ga and In were identified on the Pt-Ir wire surfaces adjacent to brittle cracks is a strong indicator that the fractures were caused by LME by one of these elements or by a Ga-In alloy. No reports of LME of Pt or its alloys by In or Ga were found in the literature. However, Ga and In have been reported to cause LME in several other face-centered cubic metals, including Al and Cu. LME usually occurs at temperatures near the solidification temperature of the liquid. An increase in temperature usually decreases embrittlement, leading to a brittle-to-ductile transition. In the present case, the experimental results for tensile tests on extracted wires suggested that the Pt-Ir wire was ductile at low temperatures (23 and 300°C; 73 and 570°F), but brittle at 900°C (1650°F). The melting points for Ga and In are 30 and 156°C (86 and 313°F), respectively. Thus, LME would be expected to occur at lower temperatures. On the other hand, Mn and Cu were associated with the Ga and In on the wire surfaces. Thus, a more complex LME interaction may have occurred.

Figure 20. Platinum-gallium phase diagram.

Many aspects of the mid-screen failure on S/N KM004 are consistent with either liquid-metal embrittlement or the formation of a low melting phase at the grain boundaries. It is concluded that one of these mechanisms probably caused the failures. Ga and In are the most probable contaminants for causing the embrittlement. However, there may have been other factors that contributed to the failure. The partial fusion between wires at the crossover points of the weave along with the dissolution of grain boundaries, voids at grain boundaries, and dislodging of grains at the saddle points of the crossovers are indicators of abnormal behavior. The causes for this instability in the grain

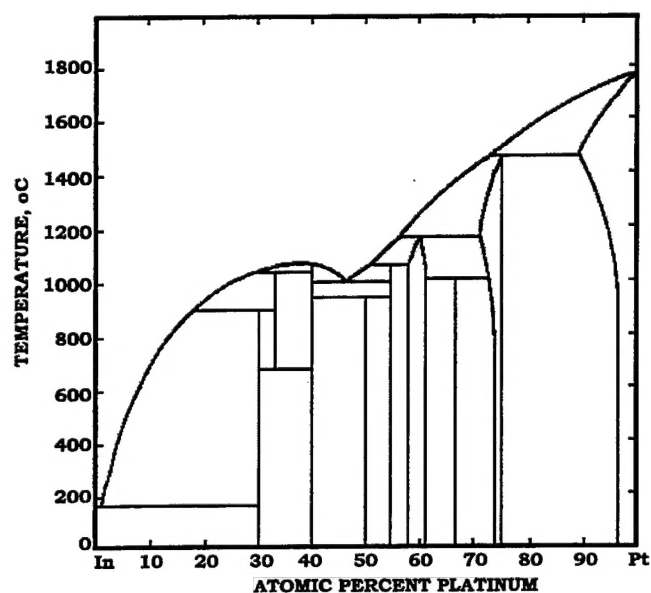
Another potential embrittlement mechanism is the formation of low-melting eutectic or intermediate phases at the grain boundaries. In this case, the alloy usually fails in a ductile mode at temperatures up to or approaching the melting point of the grain boundary phase and in a brittle fashion at higher temperatures. The Pt-Ga and Pt-In phase diagrams^{9,10} (Figures 20 and 21) demonstrate that these systems form several intermediate phases with melting points below 900°C (1650°F). This embrittlement mechanism is quite common for Pt alloys and has been reported to occur due to contamination with low concentrations of Si, Ag, K, Pb, and Se.¹⁷ Like the liquid in LME, the embrittling phase is usually easily detected on the brittle fracture surface, but in some instances is present in monolayers that are not easily detected.^{7,11,12}

Figure 21. Platinum-indium phase diagram.
